REPORT OF EVALUATION ON NAVY
CONVERSION OF RIFLE, U.S. CAL. .30, MI
TO FIRE 7.62 MM AMMUNITION BY
MODIFICATION TO THE BARREL.

SPRINGFIELD ARMORY
SPRINGFIELD, MASS.

30 OCTOBER 1964

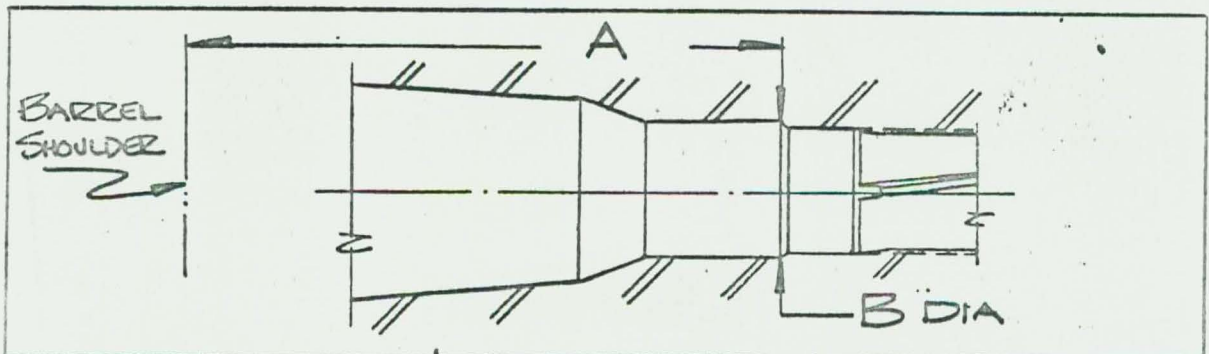
②

A review was made of M1 Rifle drawings used in connection with production of M1 barrel. Two chamber requirements affecting pre-1942 manufactured barrels at the front neck diameter and location of second shoulder were found which could significantly affect assembleability of bushing. These dimensions are shown in sketch number 2.

COMPARISON OF CURRENT & PRE 1942 CHAMBER DIMS
 APPENDIX C SKETCHES

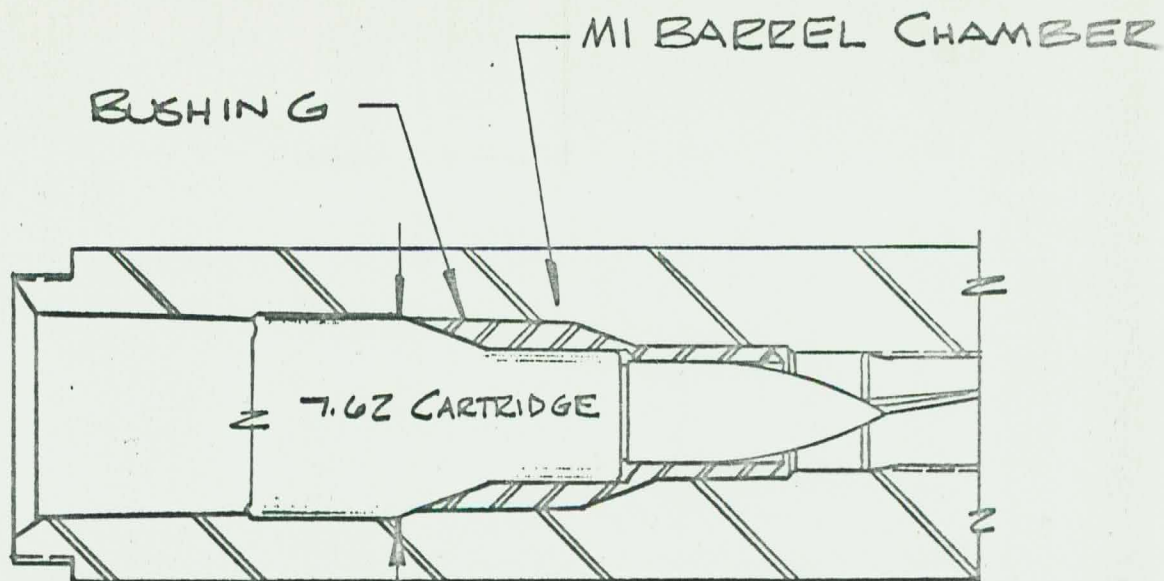
3

(1) Study showed that there can be a resultant diametral interference of .008 inch between the chamber body and the mating surface of the 7.62MM cartridge case as shown in Sketch Number 3. This would necessitate modification to M1 Rifle barrel chamber body to eliminate cartridge case interference.

This was primarily due to interference of 7.62MM cartridge case in M1 Rifle chamber body as shown in sketch number 3.

DIAMETRAL INTERFERENCE OF
008 BETWEEN 7.62MM
CARTRIDGE & MI BARREL
CHAMBER BODY

CARTRIDGE INTERFERENCE IN CHAMBER

Headquarters AWC authorized the Armory during early phase of the program to design a special reamer to remove the interference after the bushing was seated by firing two M80 Ball rounds.

cartridge by using another special design reamer. This also was not in the original procedure but was found necessary to preclude inordinate hand charging during subsequent testing. Excessive hand charging introduced a possible safety hazard. The reamed area of chamber body was polished to insure ease of cartridge extraction.

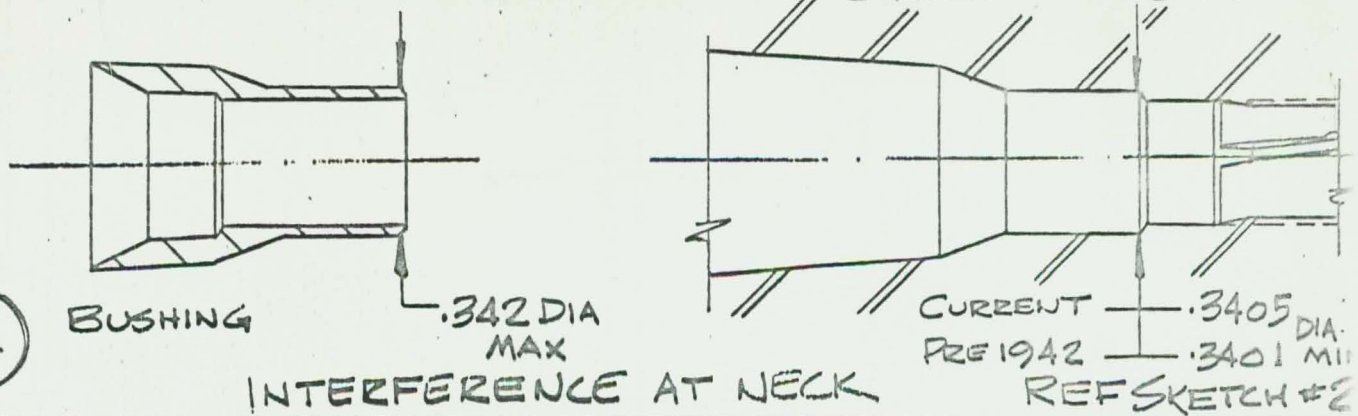
4

(3) The fit between the bushing diameter and mating barrel chamber diameter (Sketch Number 4) and the front neck can result in an interference of .0015 with current barrel requirements and .0019 with pre-1942 barrel requirements. An interference can result at the second shoulder of the barrel involving length A, Sketch No. 2. This study takes into consideration the resultant shortening of dimensions based on extremes of tolerances relative to receiver, barrel and bolt, with barrel shoulder crush and maximum stock removed from the first shoulder of the barrel during the headspacing operation of the rebuilt M1 Rifle. Sketch Number 5 illustrates that the front portion of the bushing can strike the second shoulder of the chamber and prevent the bushing from seating because of a .0015 interference (current barrel design) to .0105

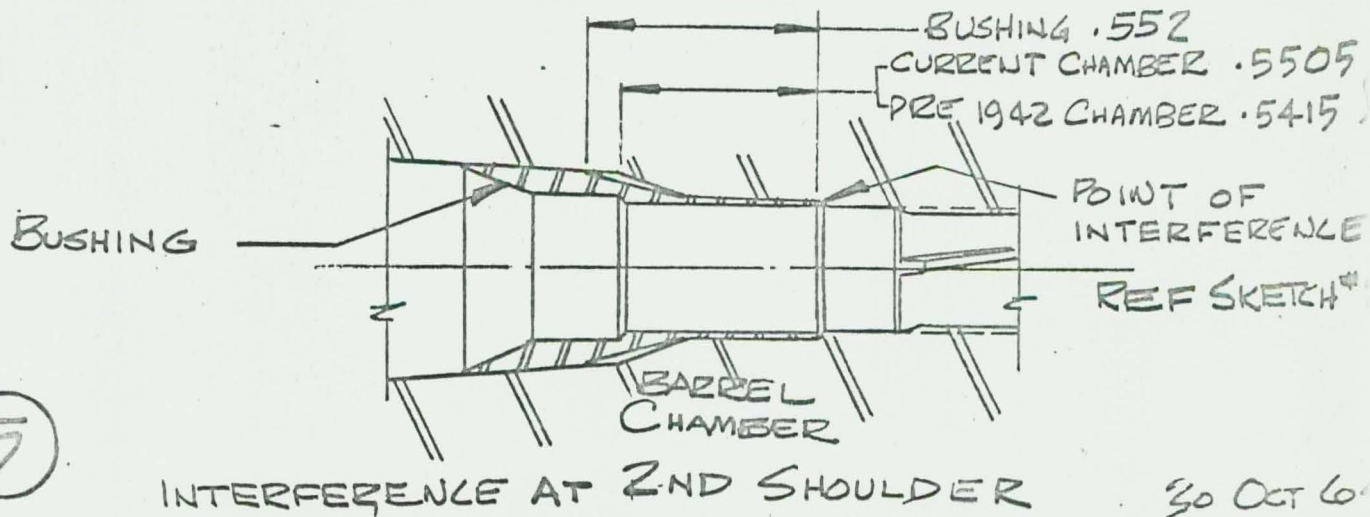
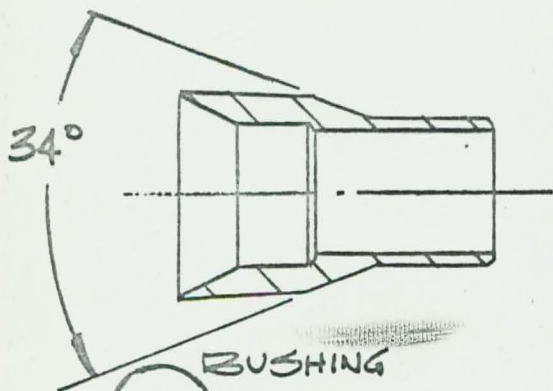
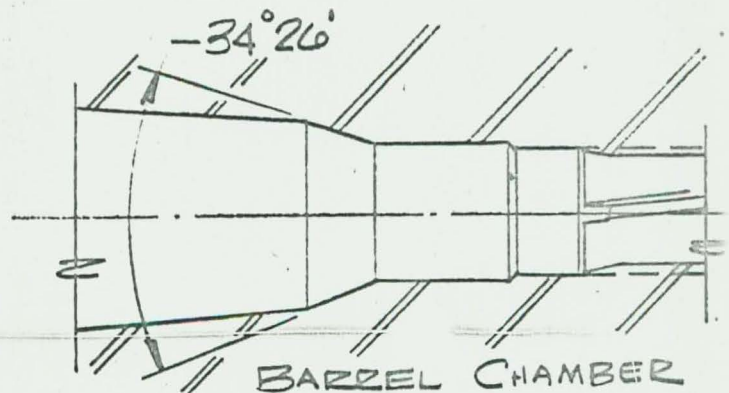
6

(4) The 34° angle on bushing is different than the $34^{\circ} 26'$ angle at second shoulder of barrel (Sketch Number 6). An interference will result between the .130R maximum of bushing and a permissible sharp corner at the second shoulder (Sketch Number 7). The above conditions adversely affect bushing assembleability or retention.

DIFFERENCE IN ANGLE OF FIRST SHOULDER

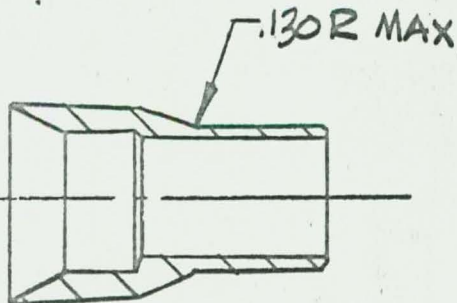
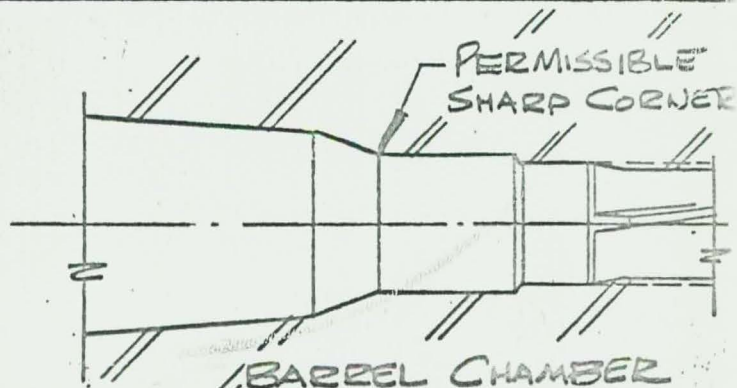
Note: This operation eliminated the interference as shown in sketch number 7 and was not included in original procedure.

RADIUS VS SHARP CORNER

of all rifles, using a special design reamer.

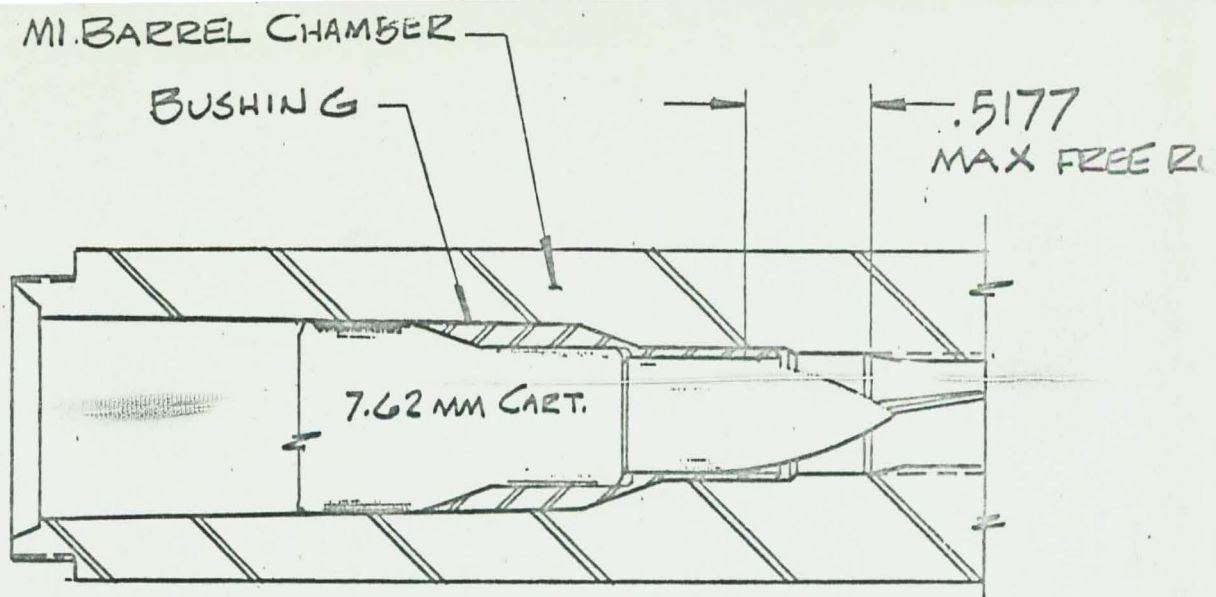
8

(5) With the bushing assembled in the barrel there may be a resultant maximum free run of bullet of .5177 inch in bullet seat area prior to engraving by the rifling (See Sketch Number 8). The maximum free travel of bullet in M1 Rifle is .065 inch. Because of length of bullet free run, greater than normal gas leakage will result in large muzzle flash. Excessive flash was observed during kinematic tests explained later in report. Gas leakage will probably accelerate erosion in bullet seat area in both original barrel and the softer bushing material. This may wear away the bushing material, affect holding force of bushing, and result in loosening or complete loss of the bushing from chamber. The bushing material does not have the erosion resisting qualities of the original barrel material. A loose bushing in barrel will disable the weapon. Complete loss of bushing can result in double feeding, one live round into another.

MAX BULLET FREE RUN (M1 - .005
M14 - .008)

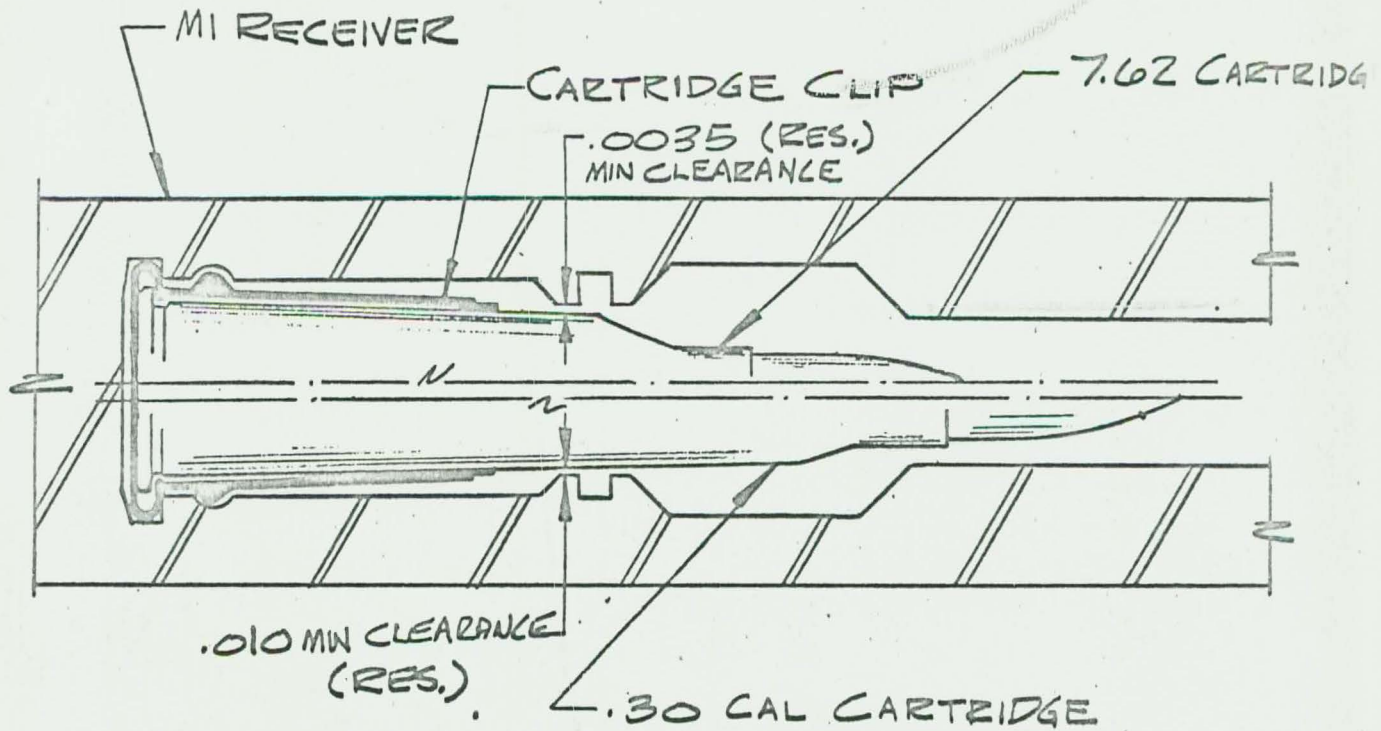
(2) Sketch Number 9 shows the minimum clearance between a cartridge clip loaded with Cal .30 ammunition, inserted into the receiver as compared to a cartridge clip loaded with 7.62MM ammunition. The .0035 minimum clearance that may result in certain weapons with a cartridge clip filled with 7.62MM ammunition may be marginal, especially when the rifle is exposed to dust and dirt.

MINIMUM CLEARANCE IN MI RECEIVER WHEN
8 ROUND CLIP IS LOADED WITH CAL.30 AMMUNITION
AND WHEN LOADED WITH 7.62 MM AMMUNITION
